## Helping Floodville

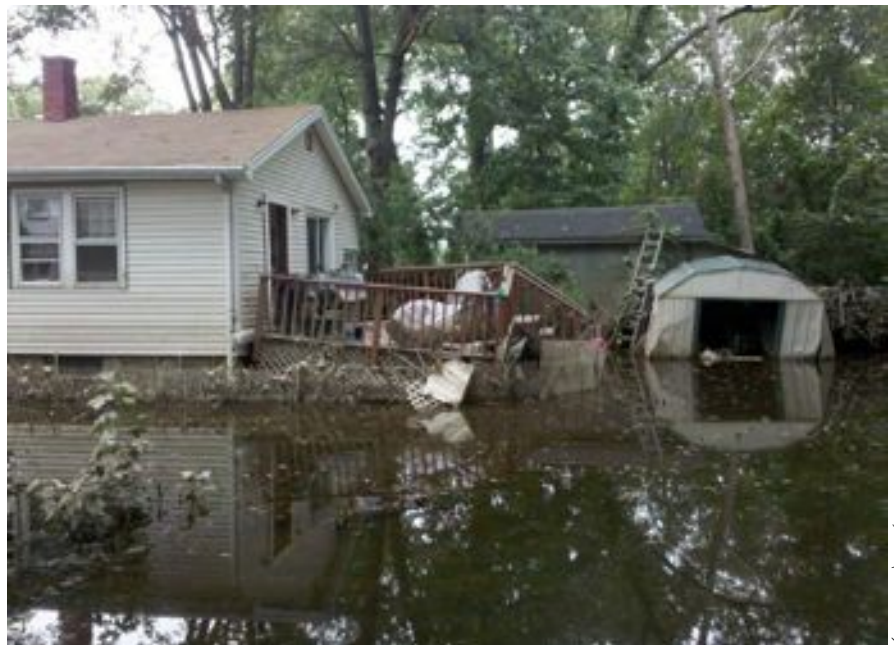
G.C. Stewart Associates, Inc. (9/5/2011)

**Tropical Storm Lee hit New Jersey less than a week after Hurricane Irene left town late August 2011, and the cumulative 20-plus inches of rain made life even more miserable for homeowners already applying for buyouts. Stains on the house siding show the most recent height of floodwaters.**
